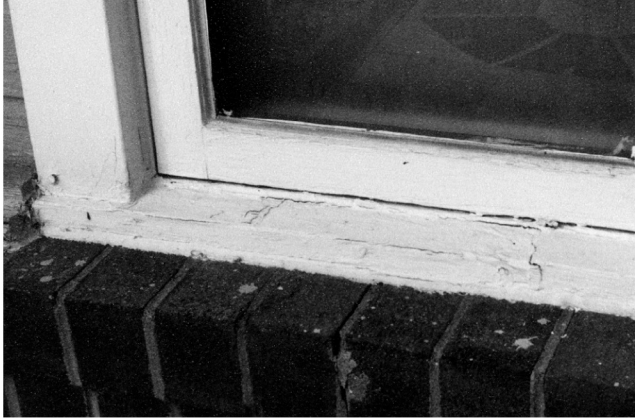
**2.11.4a. Paint Failure** *The paint is cracking because it is not acting as a film to protect the sill. Water seeping in will damage the sill and brick molding. Paint failure has many forms and appearances.*

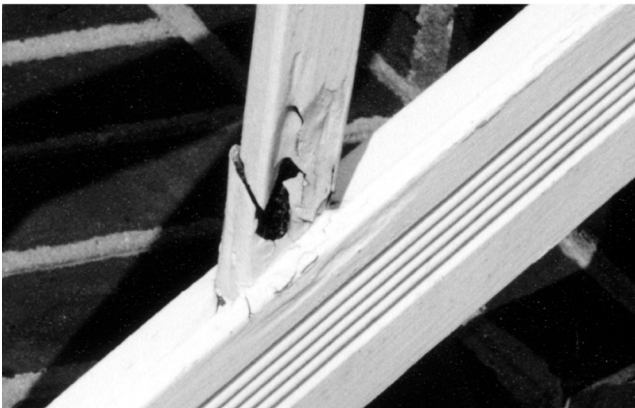
**2.11.5a. Wet Rot or Splash Damage.** *The picket on this rail is rotting. The cure is to replace it with a rot resistant material such as redwood or cedar. Also consider vinyl or aluminum railing systems.*

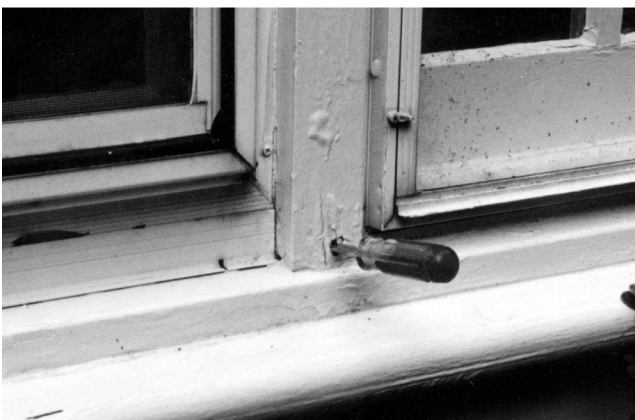
**2.11.5b. Wet Rot or Splash Damage.** *The window trim is rotting. If there are no gutters, it would be wise to add them. Awnings help keep windows dry, but can be maintenance problems themselves.*

Any rotting trim, brick molding, sills, jamb parts, etc. should be replaced. Replace the entire piece rather than cut away part and risk missing some of the rot. (See the Example above.) Cut
